COLORCOTE®

Number 1 – July 2008.

ColorCote® ARX™ and AR8™ Roofing – Protection of Underside of Sheet Edge at and below First Purlin.

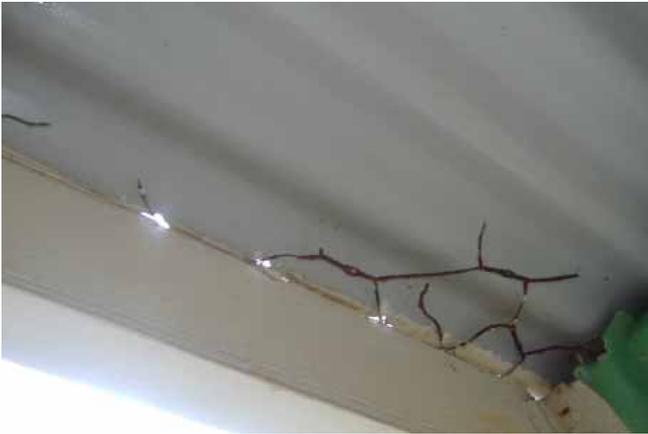
If the gutter is installed such that its front does not 'cover' the profile of the roofing, or if it stands off from the fascia, wind blown salt-laden air can be driven up and under the roof/paper/netting to the bottom purlin. Combined with contaminants, this mixture rusts the netting and saturates the paper, allowing the rusting netting to come into direct contact with the ARX™/AR8™. When this happens holes will develop in the aluminium in a very short period of time.

Paper has rotted away, netting has corroded, ARX™ has perforated as a result.

1. Always use new paper underlay.
2. Use self-supporting paper. If the pitch is under 8 degrees the use of some type of support is required by the Building Act – do not use galvanised wire netting, but a strapping or similar.
3. Run the paper to just below the bottom purlin, not to the gutter. Use a sacrificial eave flashing from the bottom purlin to the gutter. Refer to the NZMRM Code of Practice for details.
4. Ensure the ARX™/AR8™ is separated from any paper or flashing fasteners.
5. Install the gutter so that it protects the profile ends.
6. Try to design the building so its aspect is such that the profile ends face away from the driving wind/salt spray.

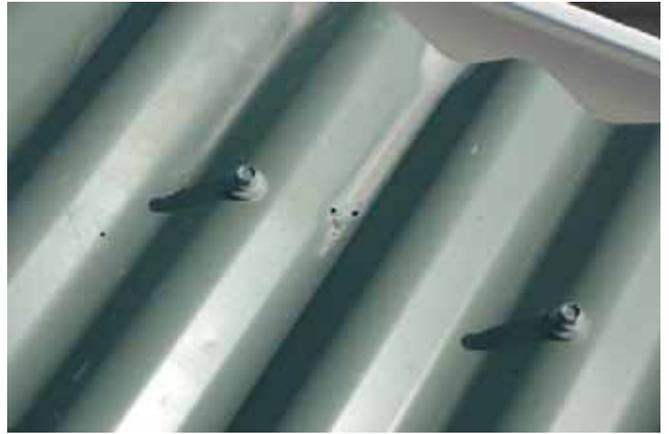
Perforation of the ARX™ at the bottom Purlin.

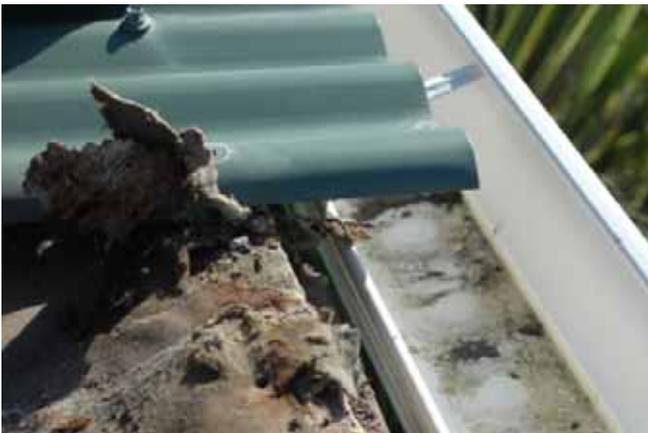
Gutter is installed incorrectly, paper has been rotted away, netting has rusted away, ARX™ has been perforated as a result.

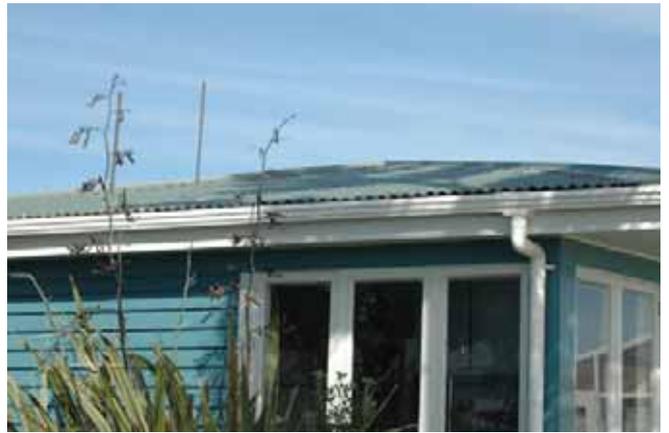
Gutter installed well below profile line, so it doesn't stop salt and contaminant laden air from being blown under the roof.
